Debris/Ice/TPS Assessment And Integrated Photographic Analysis For Shuttle Mission STS-49

July 1992

Gregory N. Katnik
NASA/Kennedy Space Center

OV-105 Endeavour (1st flight), ET-43 (LWT 36), BI-050 SRBs

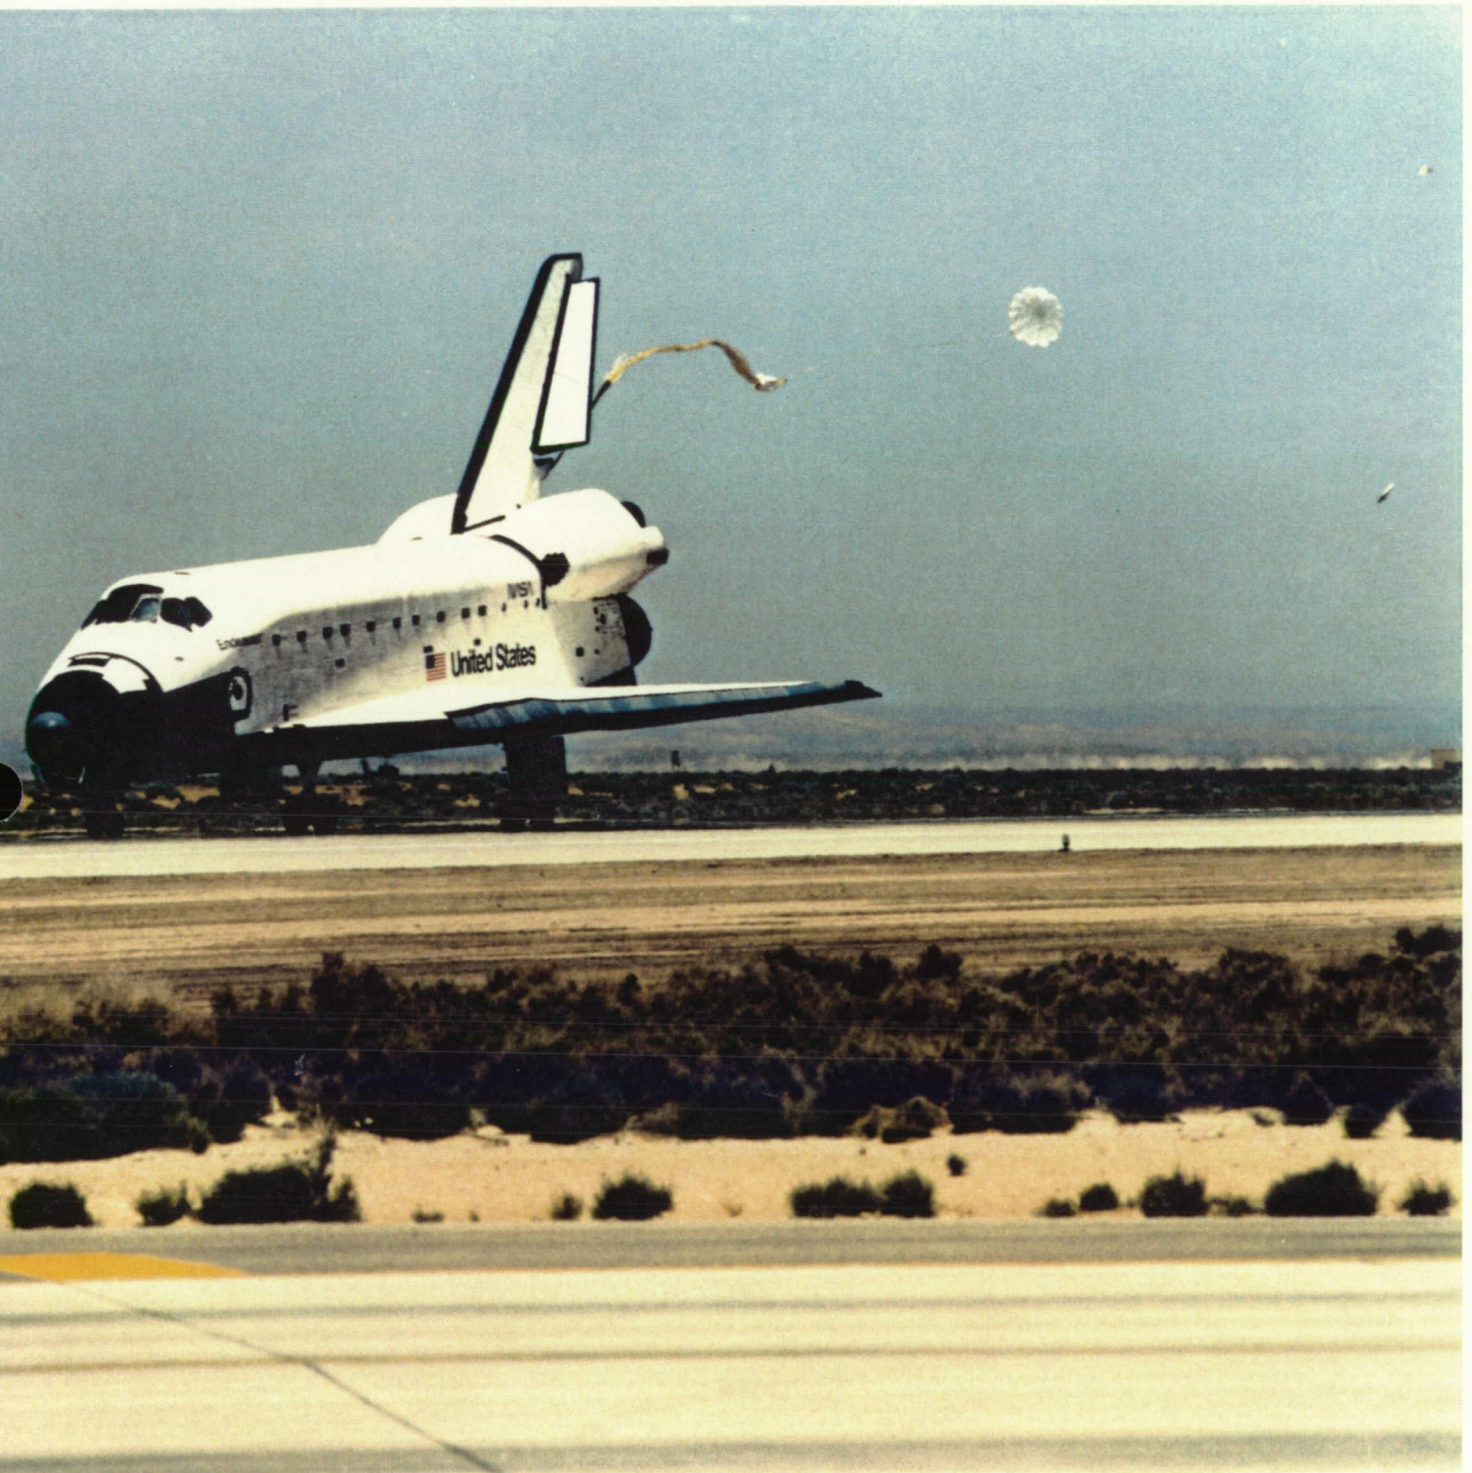
This flight marked the first use of the Orbiter drag chute, which functioned normally. The drag chute compartment door and the sabot/pilot chute bag are visible at the right side of the frame.

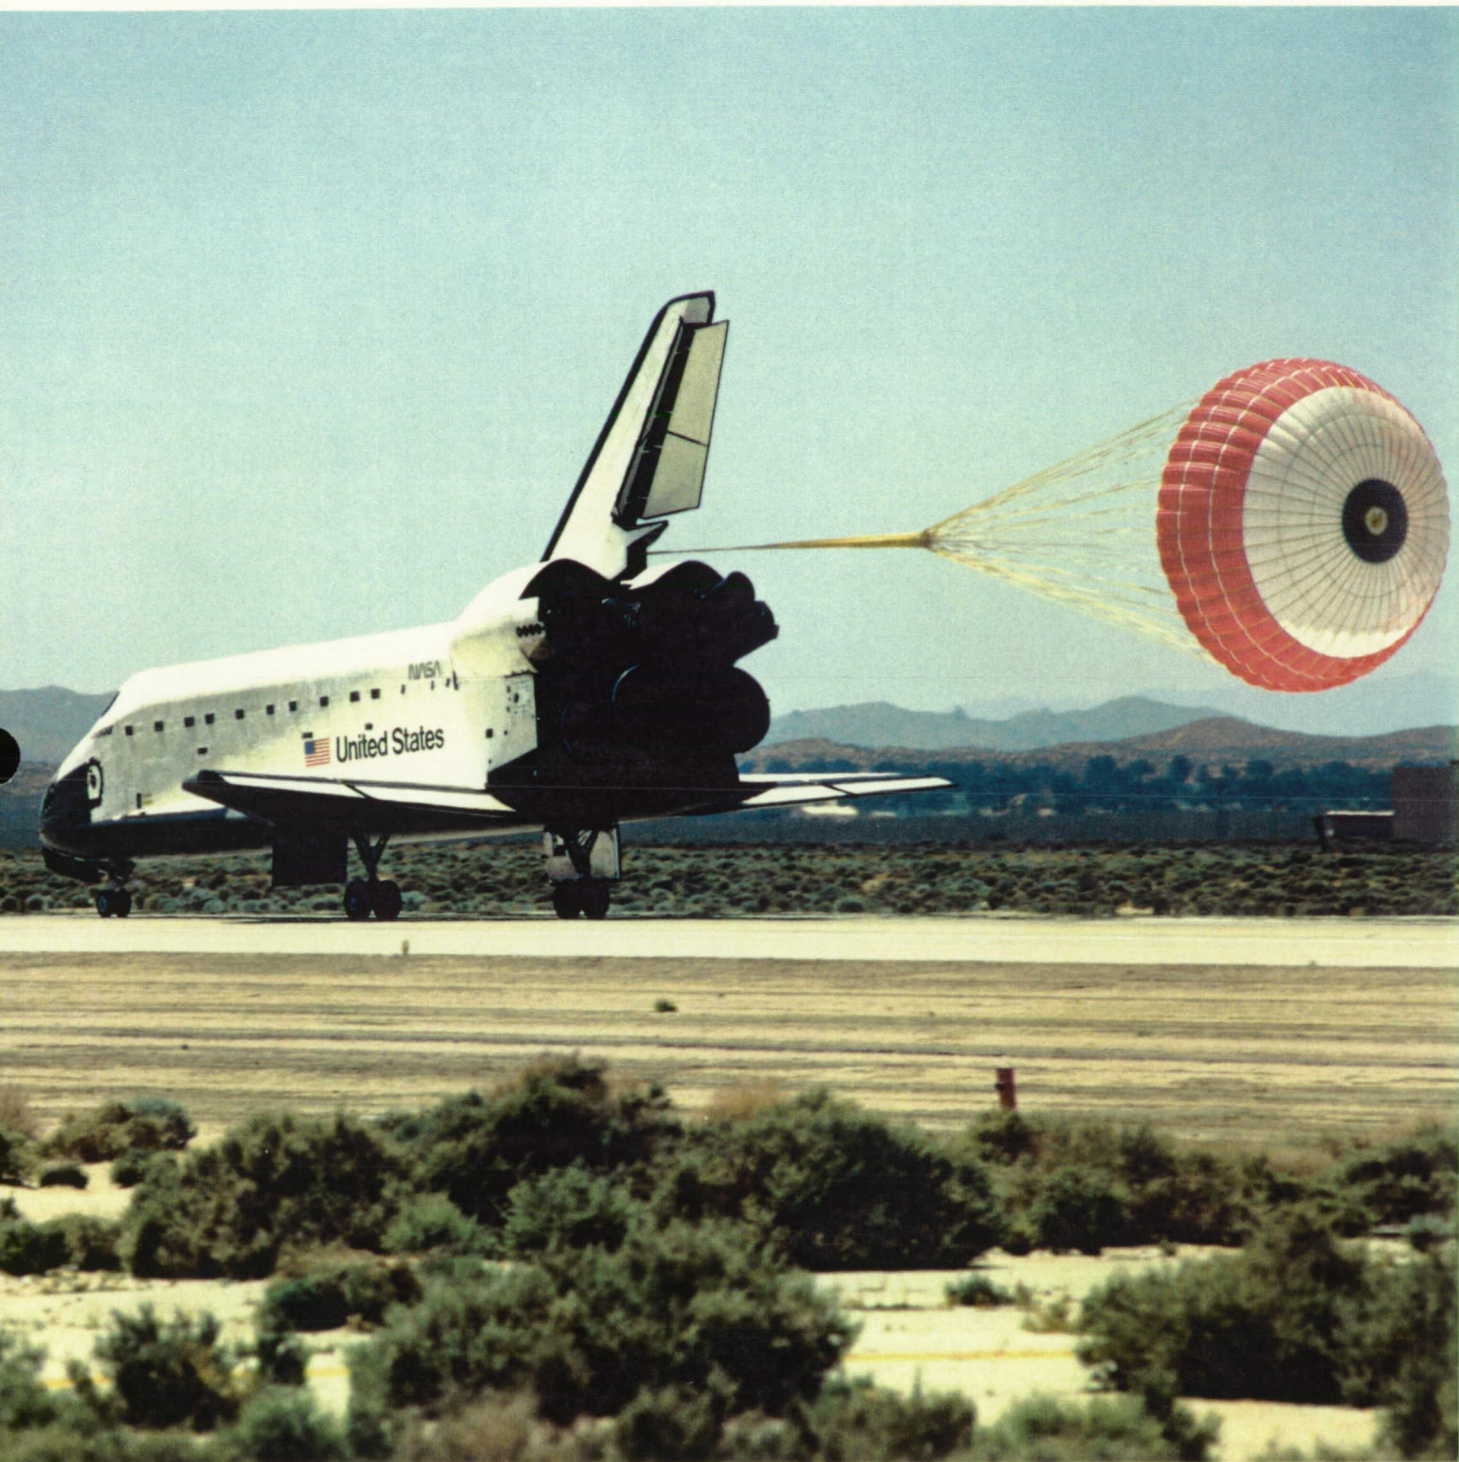
Deployment of the drag chute was nominal. The risers did not contact the SSME #1 nozzle or the rudder/speed brake.

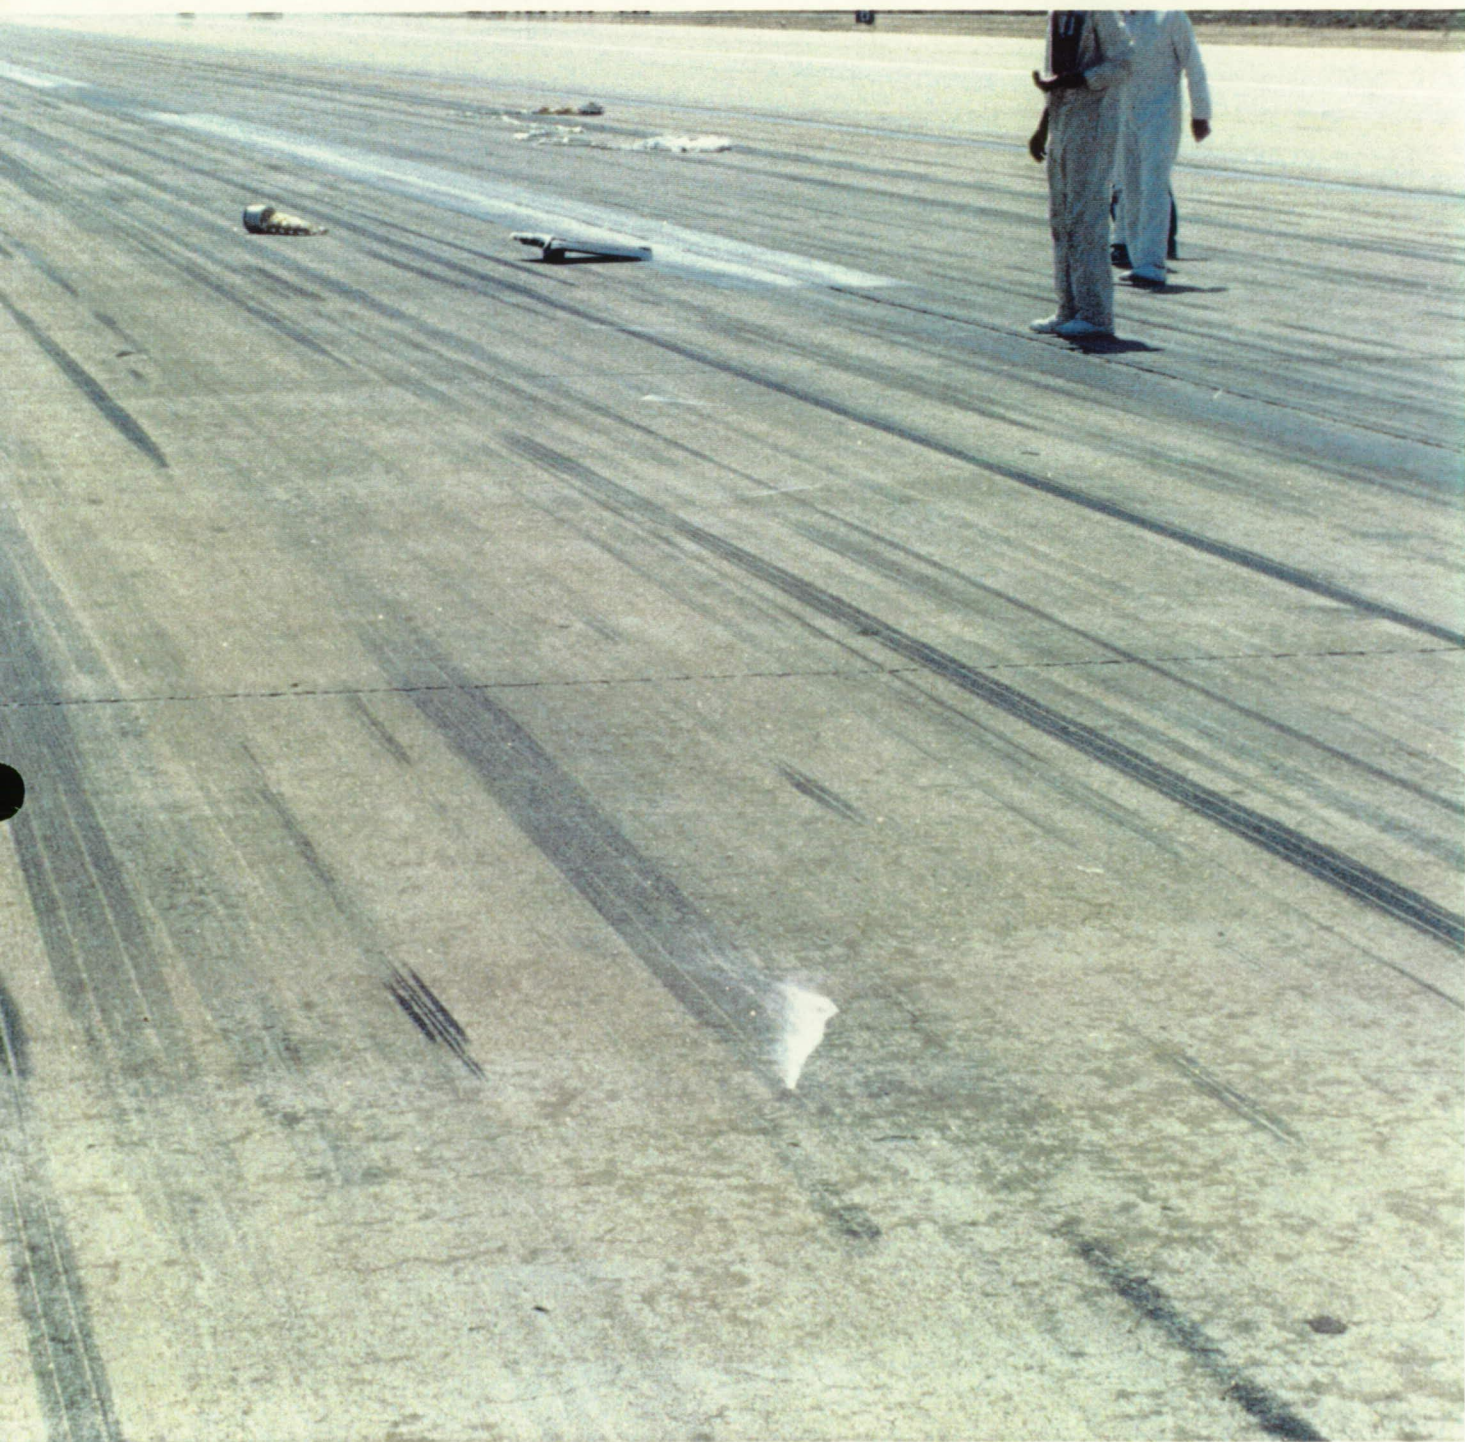
Post deploy positions of the drag chute compartment door, sabot with attached pilot chute bag, and pilot chute on the runway. Note white impact marks made by the drag chute compartment door.

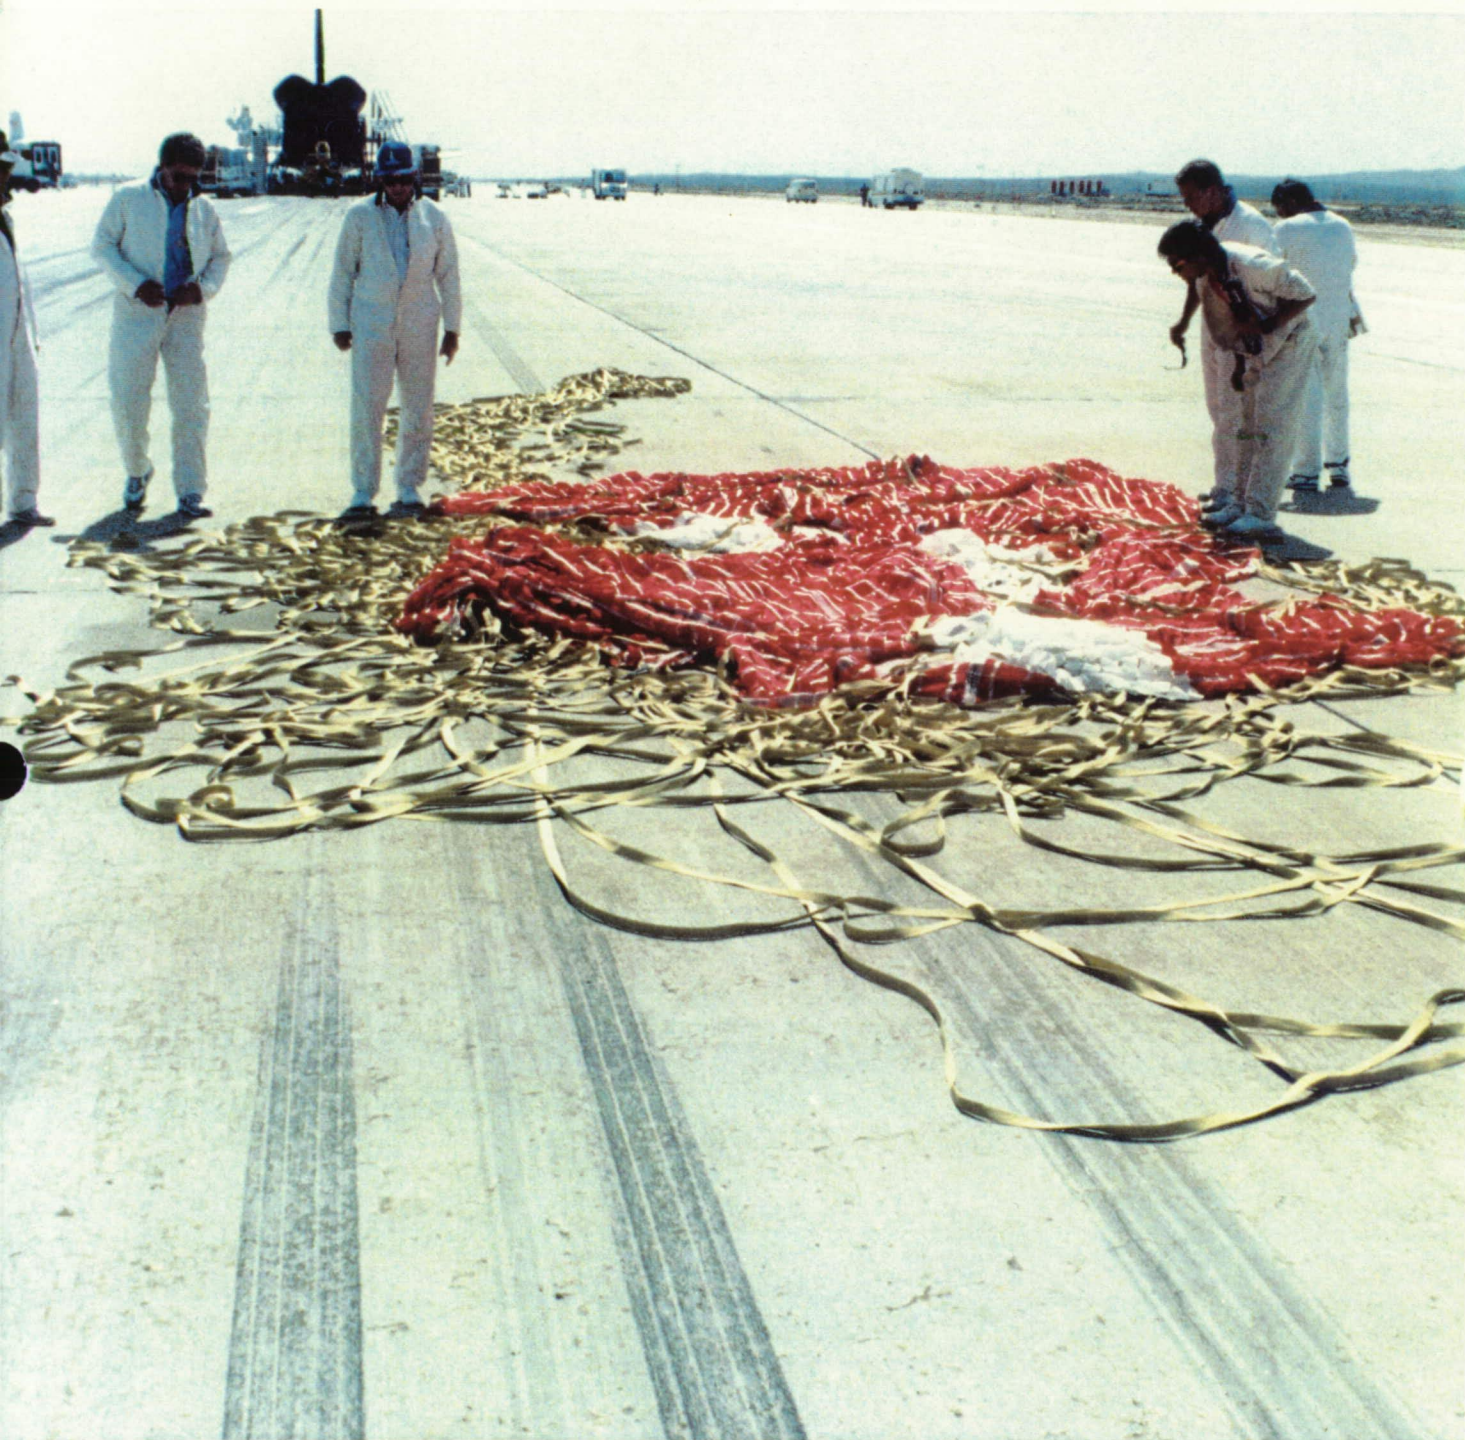
The drag chute was located approximately 750 feet aft of the Orbiter and just to the right of the centerline. All drag chute hardware was recovered and showed no anomalies.

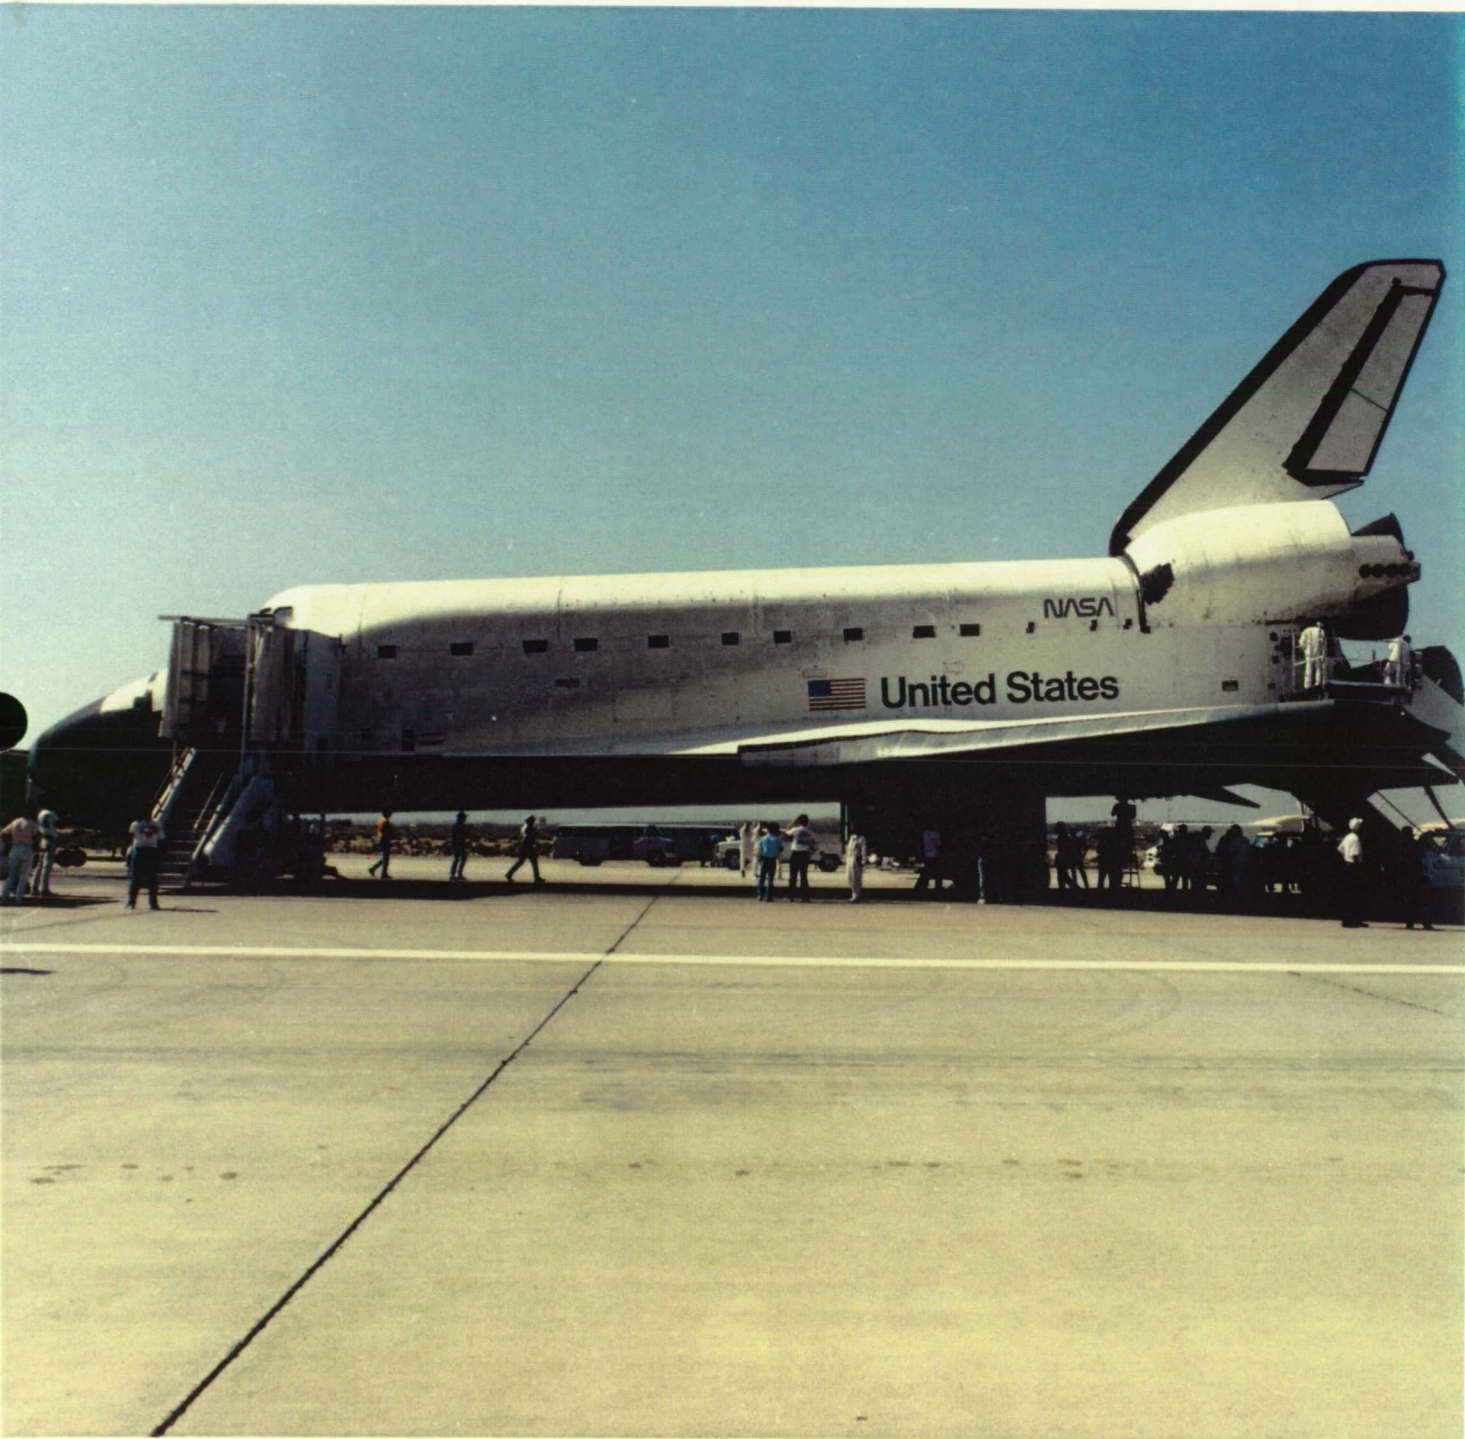
Overall view of Orbiter left side. Note discolored vent door #3

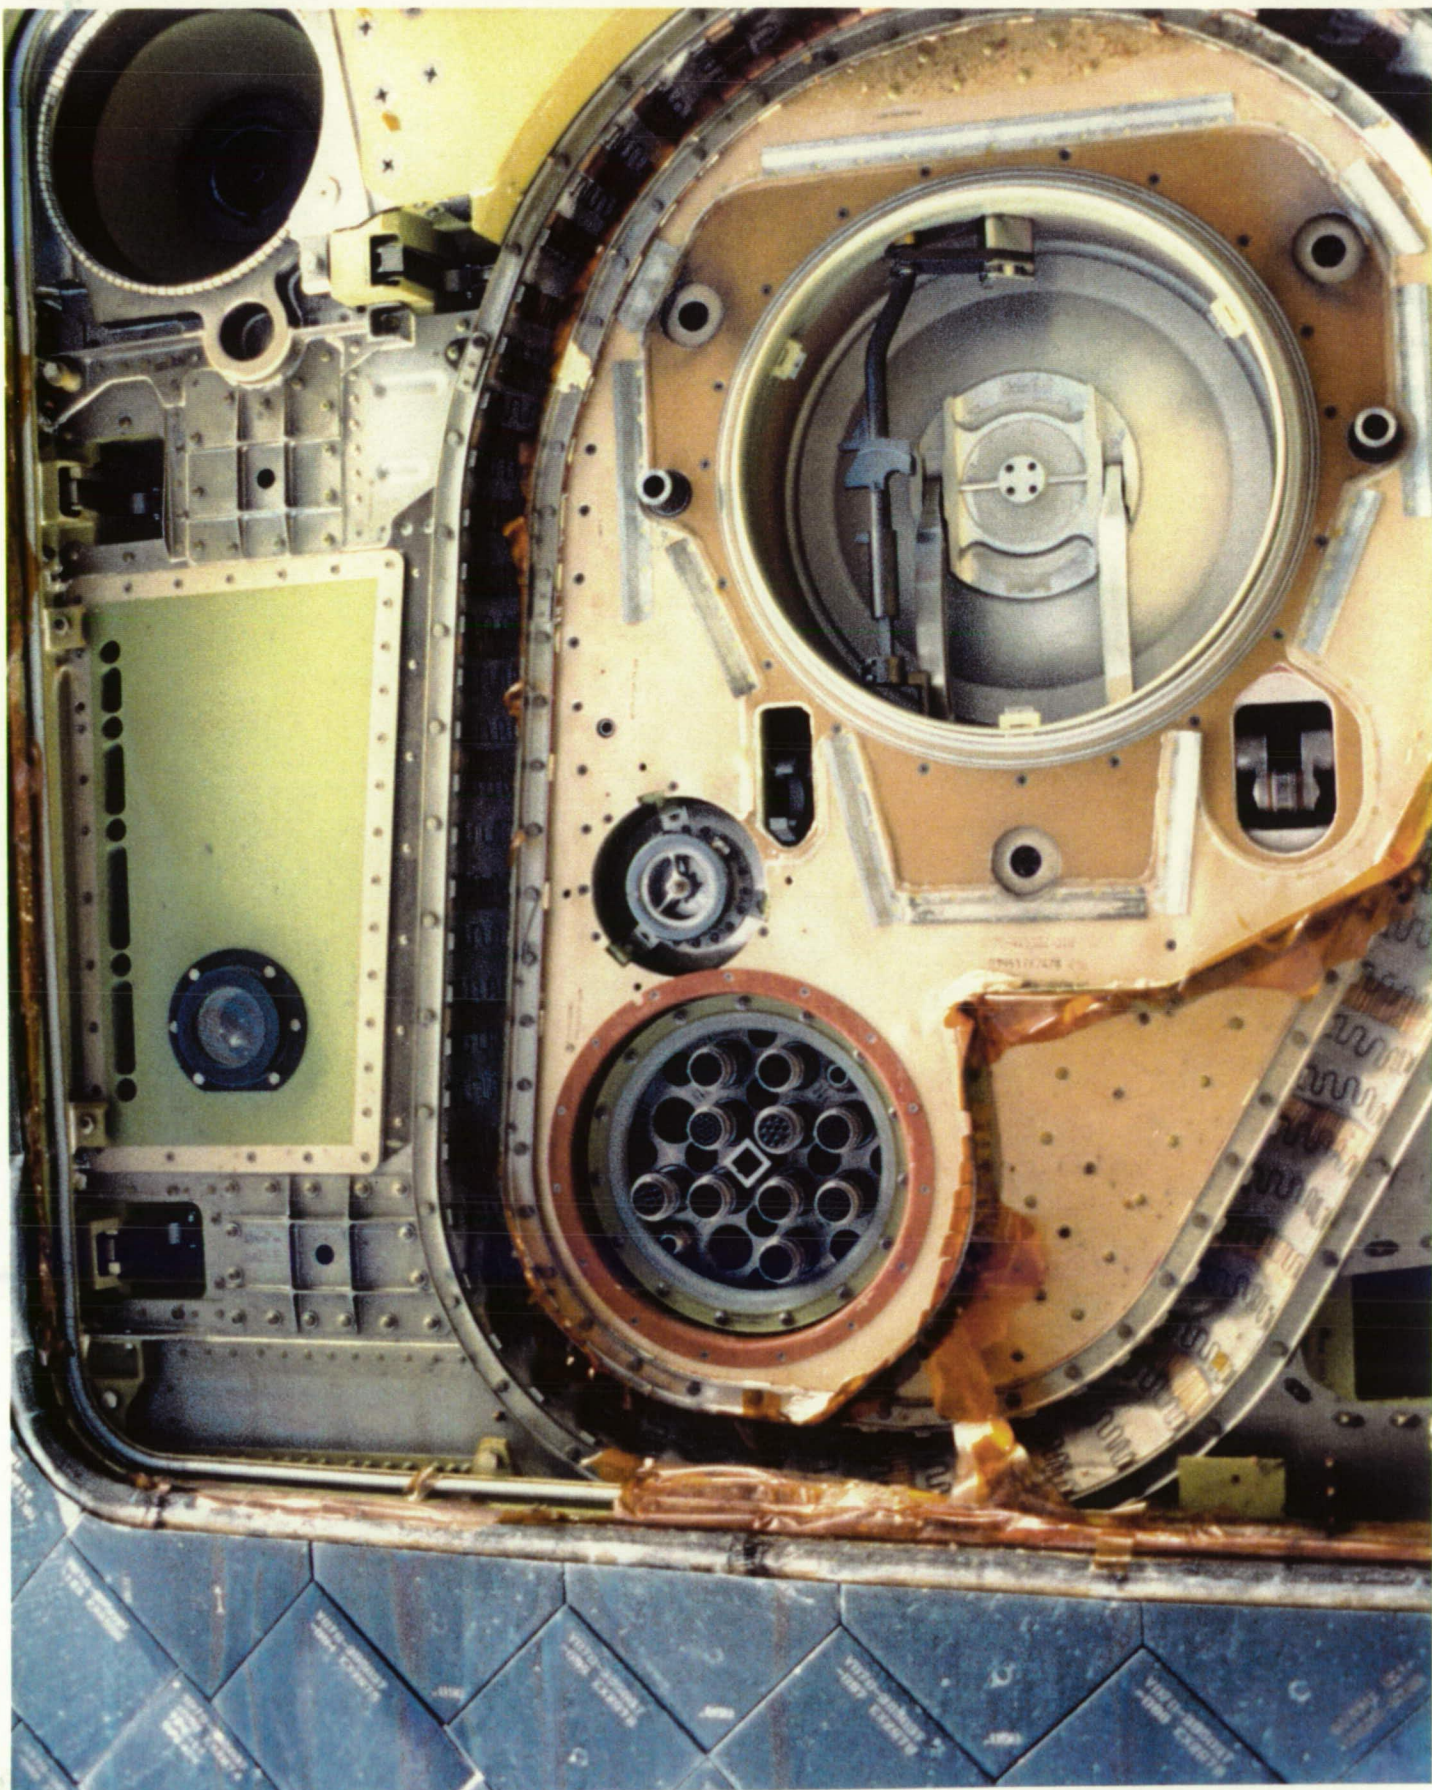
Overall view of the LO2 ET/ORB umbilical. All separation ordnance devices appeared to have functioned properly.

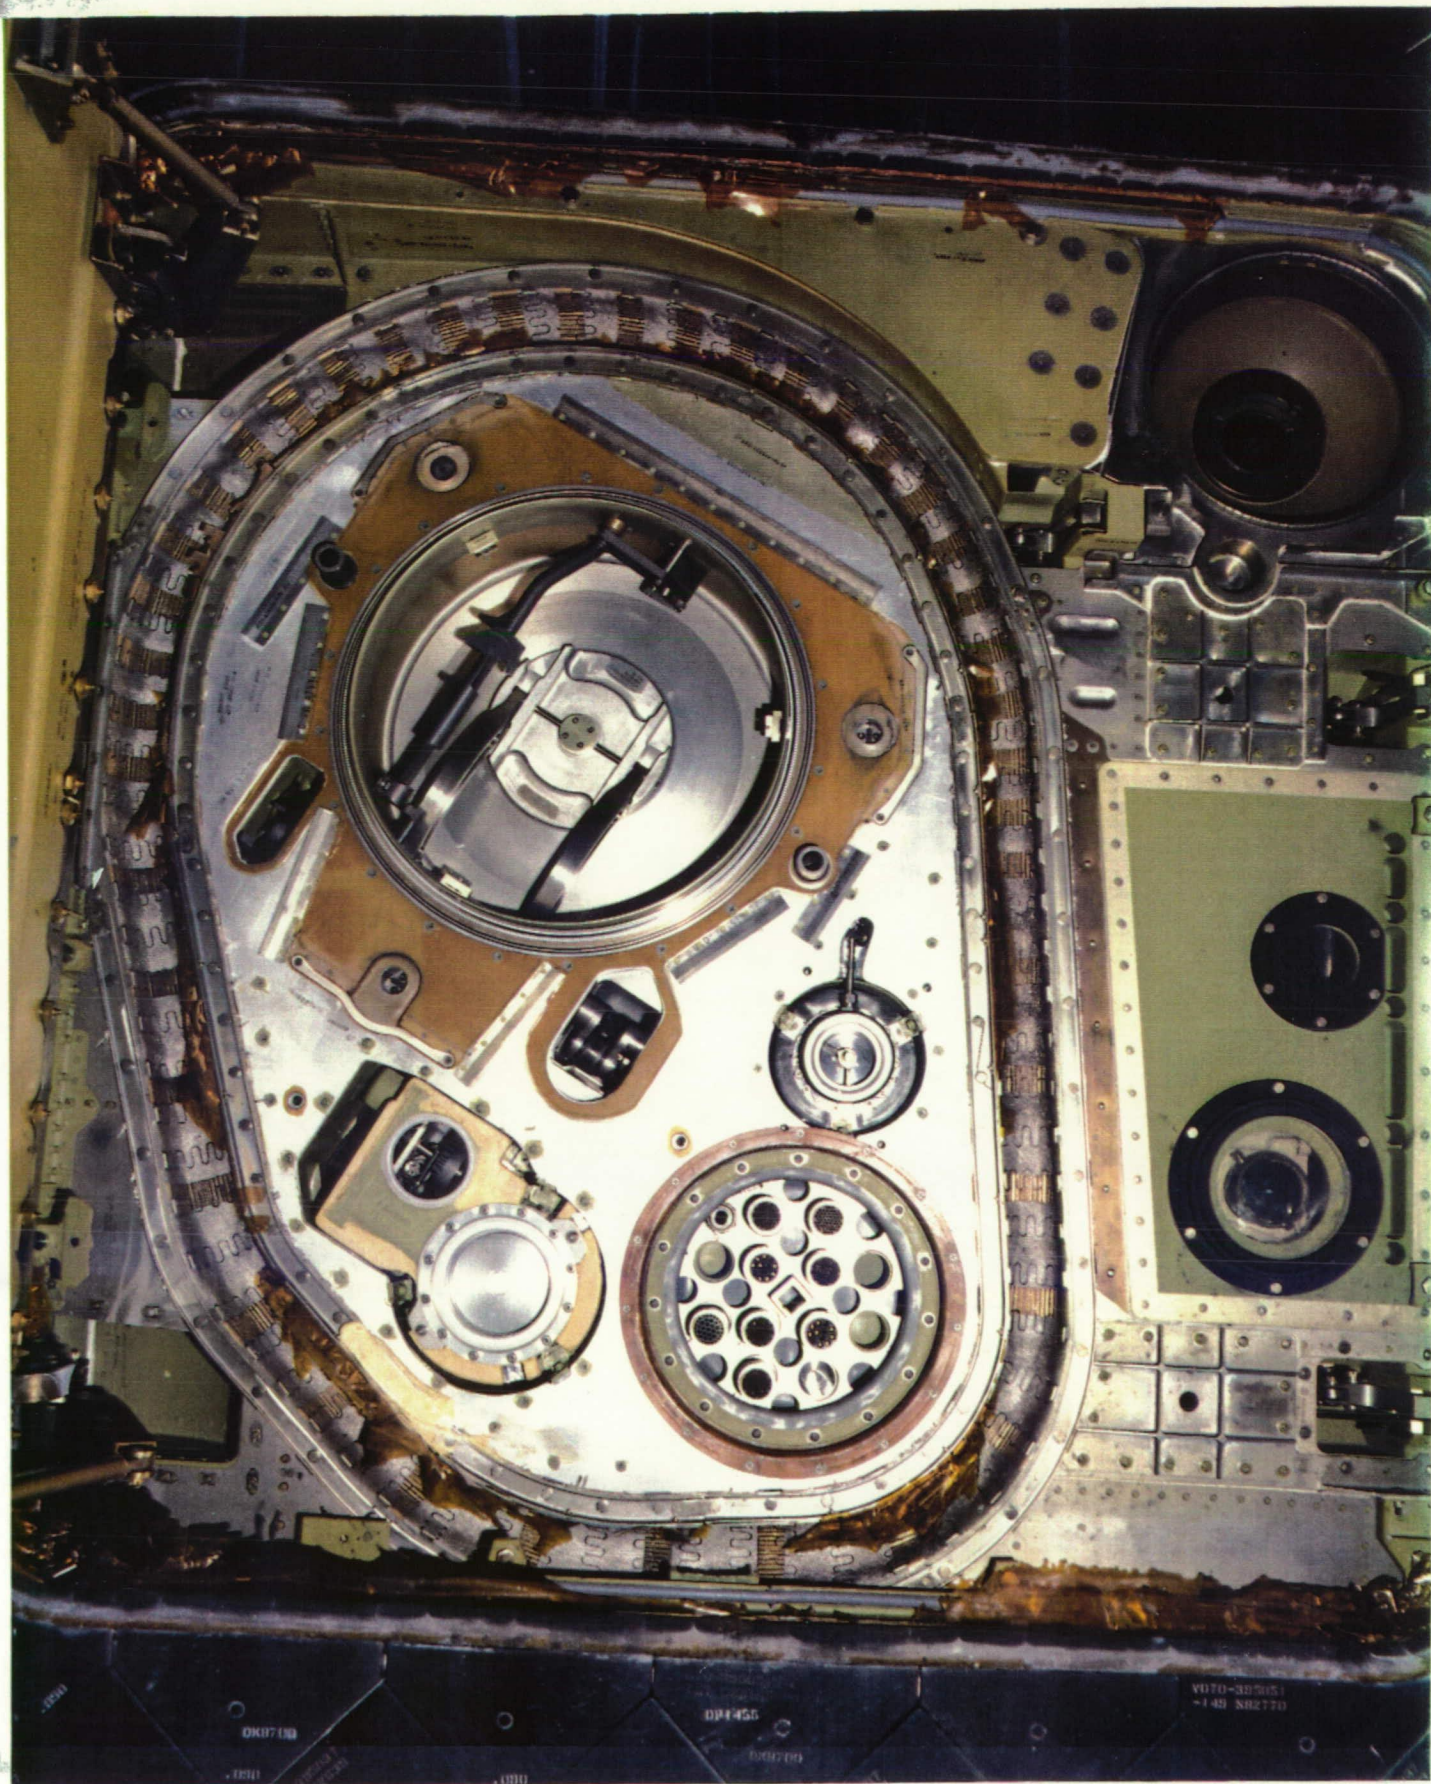
Overall view of the LH2 ET/ORB umbilical. All separation ordnance devices appeared to have functioned properly.

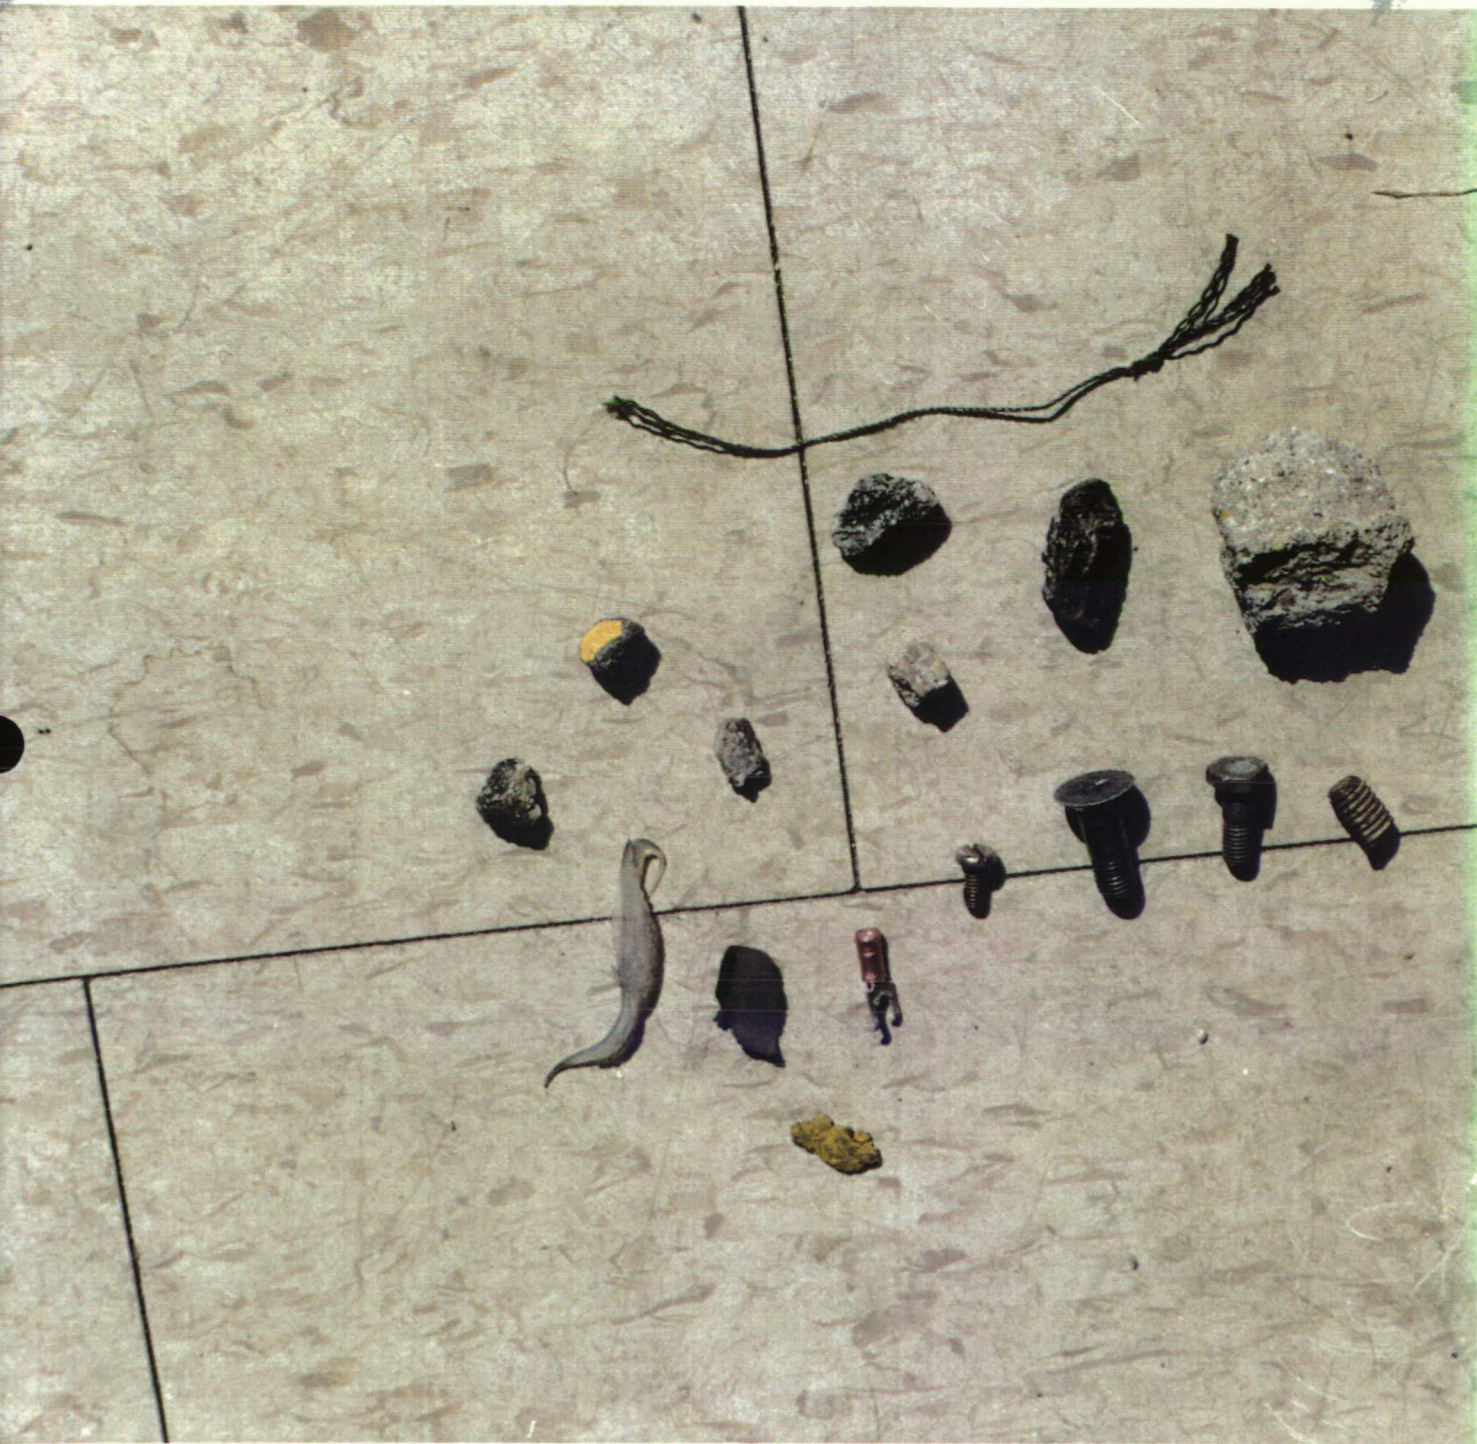
Non-Orbiter debris collected from Runway 22 during the
Post Landing Runway Debris Inspection

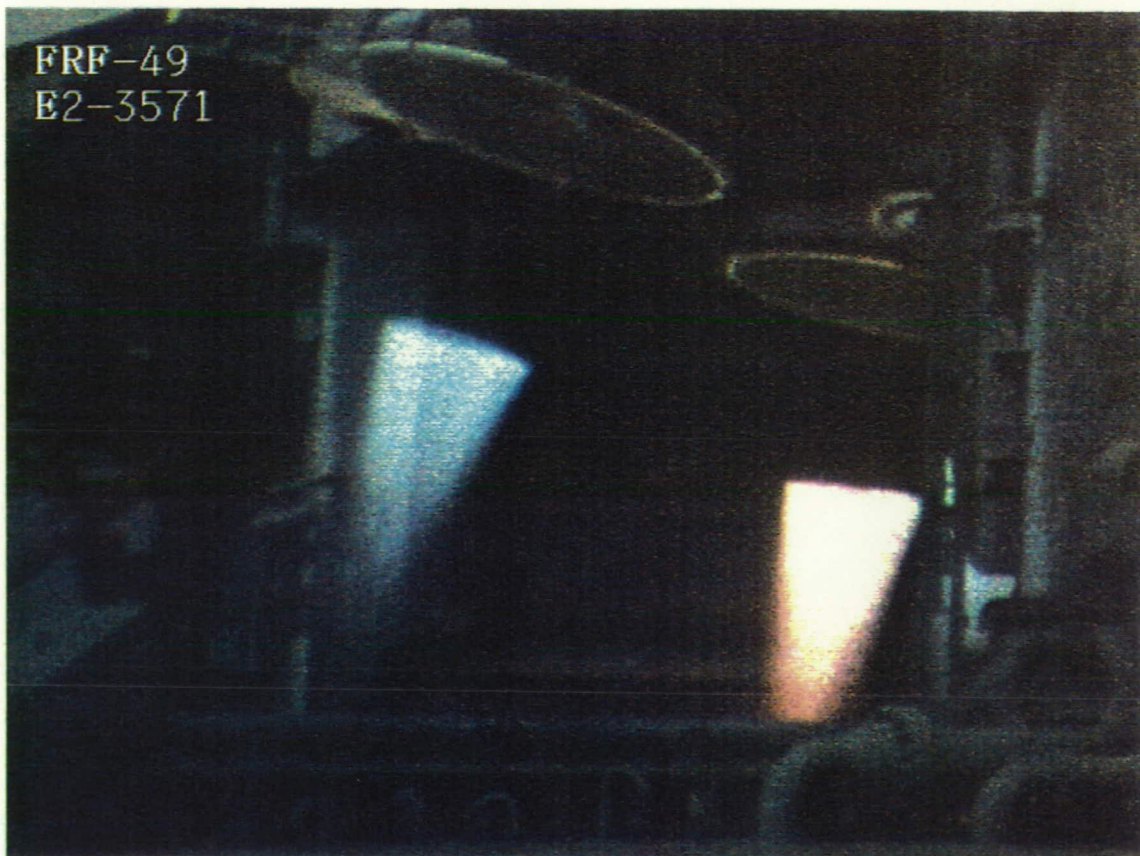
Figure 2.1

Orange Discoloration in SSME #2 Exhaust Mach Diamond

The orange discoloration in the SSME #2 mach diamond contrasts against the normal blue/white mach diamond color as shown above. Multiple (over 60) orange discolorations were seen in the SSME #2 mach diamond during the engine test firing. The orange discoloration typically lasted about 0.01 seconds.

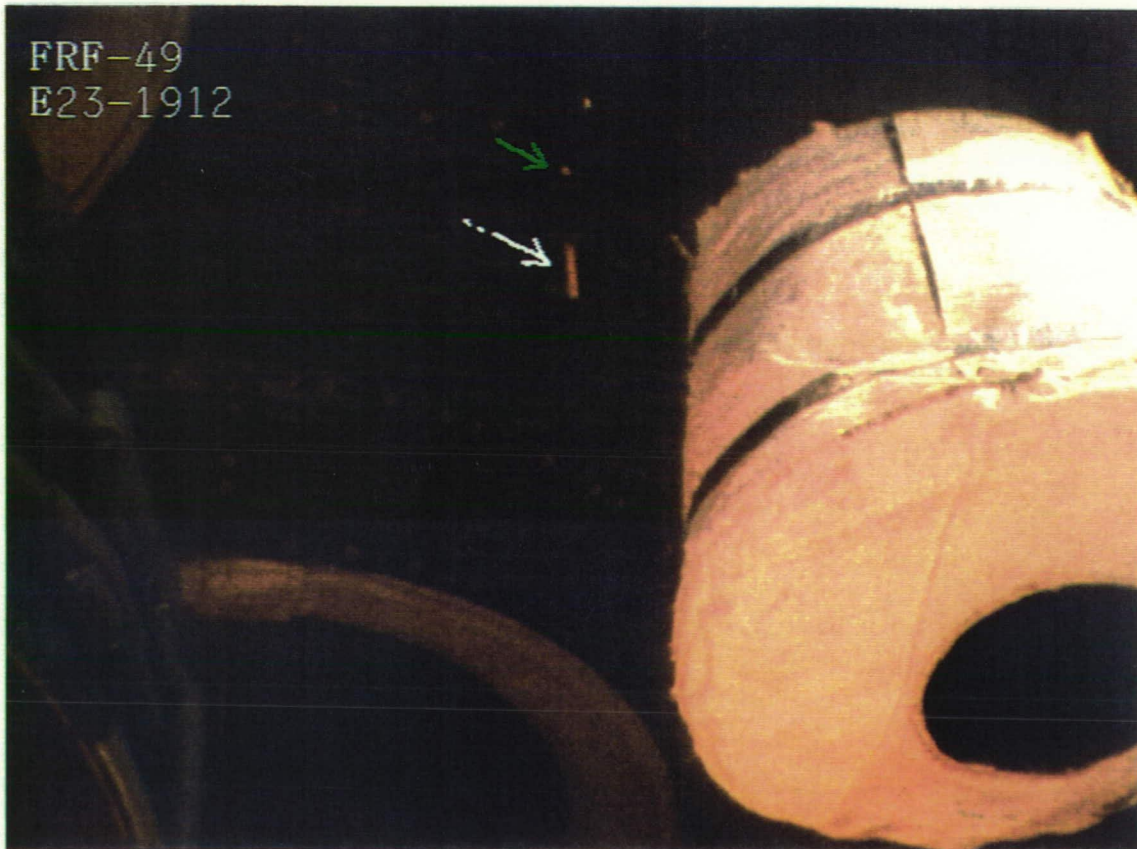
Figure 2.2 **Probable Tile Spacer Debris**

A long, rectangular, red appearing object was seen coming from the base heat shield near the right OMS nozzle during the engine test firing. The object appeared to be a shim or spacer that came from between two tiles. Tile spacer debris was seen on previous missions STS-27R and STS-28R during SSME ignition. See figure 2.2.

A long, rectangular, red appearing object (white arrow) was seen coming from the base heat shield near the right OMS nozzle during the engine test firing. The object appeared to be a tile shim that dislodged from between two tiles. The green arrow points to an area of base heat shield erosion that occurred during the engine firing.

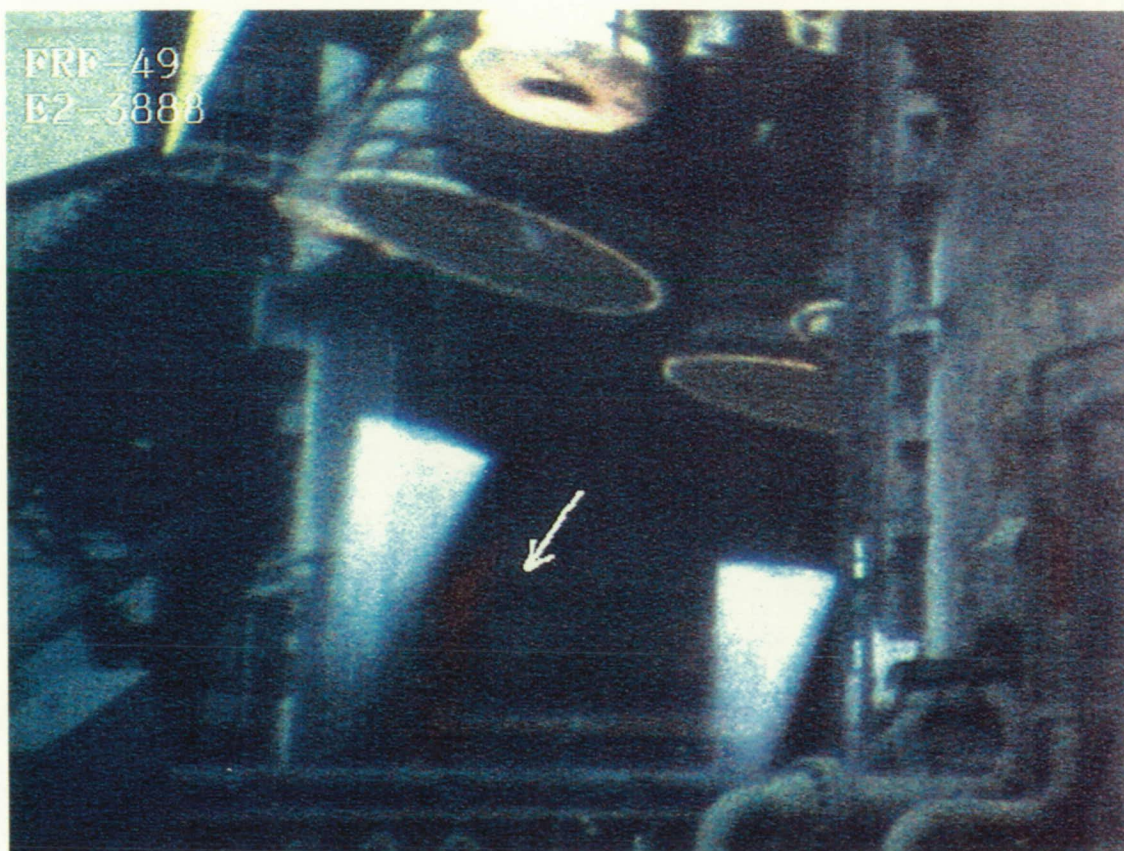
Figure 2.3

A small orange flash was seen on the aft edge of SSME #1 exhaust plume near the mach diamond at 15:12:08.734 UTC. See figure 2.3. Orange flashes are often seen during SSME ignition prior to liftoff and have been attributed to small debris (ice or RCS paper) coming in contact with the hot exhaust gases.

Orange Flash in SSME Exhaust Plume

A small orange flash was seen on the aft edge of SSME #1 exhaust plume at 15:12:08.734 UTC.

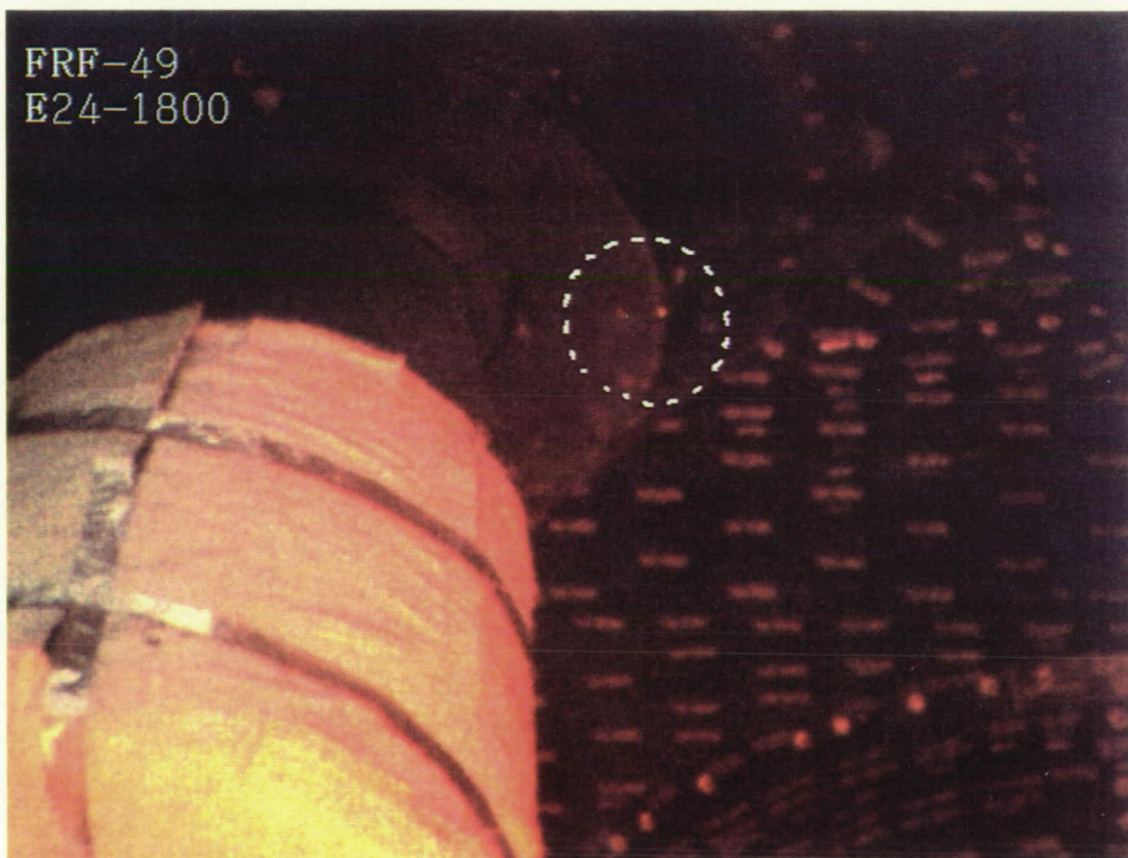
Figure 2.4

Tile surface material was seen to detach from a small area on the base heat shield at the base of the right OMS nozzle and fall aft as three separate pieces. See figure 2.4. A small area of base heat shield erosion was also noted at the base of the left OMS nozzle. Base heat shield erosion has been seen on previous missions from the camera E-023 and E-024 close-up views.

Base Heat Shield Deterioration

A small area of base heat shield erosion (circled) formed at the base of the left OMS nozzle during the engine firing. A second area of base heat shield erosion near the right OMS nozzle can be seen in Figure 2.2.
